Appendix C
Hazardous Materials

Re: Kingsbridge Armory Project
1 West Kingsbridge Road
Block 3247, Lots 2 and 10
CEQR # 25DME006X

AKRF, Inc. (AKRF) is pleased to submit this Phase I Environmental Site Assessment for the above-referenced Subject Property. This report includes the findings of a reconnaissance of the Subject Property, and an evaluation of readily available historical information and selected environmental databases and electronic records. The report meets the requirements of ASTM International Standard E1527-21, unless noted otherwise in Section 7.0, "Limitations and Data Gaps."

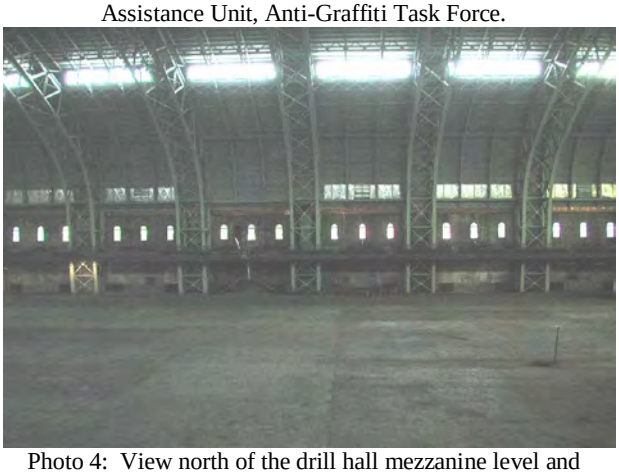
Photo 4: View north of the drill hall mezzanine level and replacement roof over the drill hall.
